# Lake St Lucia: understanding the problem and finding the solution

Background Information Document (BID 2011/07)

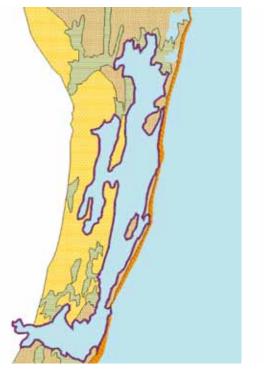
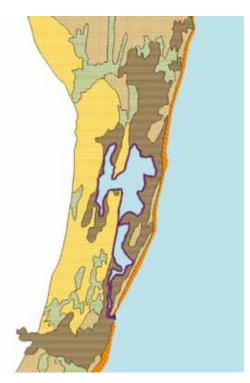
A) 6000 years ago

B) Present

Figure 1. The size of Lake St Lucia has changed over time due to 6000 year old natural sediment accumulation. (Taylor, April 2011)

Lake St Lucia was originally a deep lake that extended northwards into what is now the Mkhuze swamps, and the present Mfolozi floodplain (Figure 1). Sea levels rose rapidly to the present level about 6000 years ago moving the estuary up the river valley, resulting in flooding of the low lying area behind the dunes forming the large lake system shown in A. Over the past 6000 years natural infilling of the lake and floodplains with sediment has produced the smaller and shallower system we see today (B)

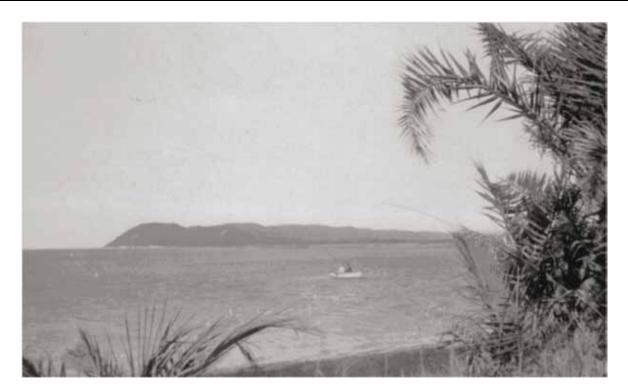
Figure 3. Up until 70 years ago the St Lucia Bay stretched from the current day ski-boat club to Maphelane (photographer: unknown)

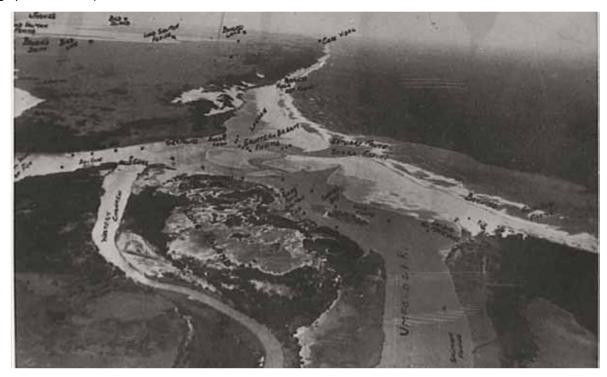
Figure 4. A postcard from 1936 showing the combined St.Lucia Estuary & Mfolozi River mouths

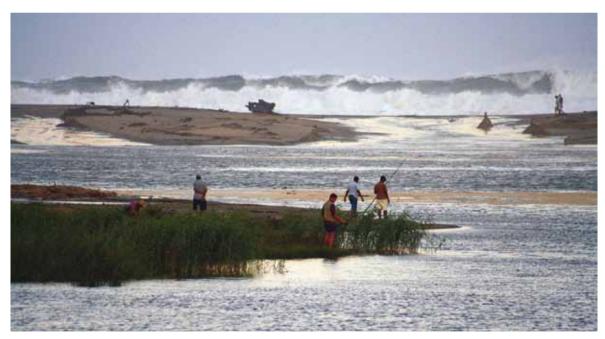
Fig 6: In 2007 Cyclone Gamede caused high seas that breached the St Lucia mouth, resulting in the inflow of sea water into the Narrows and the lake. With low water levels and insufficient flow out of the lake the mouth closed after about 5 months (photograph: iSimangaliso Authority).

It is not unknown for the sea to breach a sand bar and open the estuary mouth. For instance, in March 2007 Cyclone Gamede formed out at sea, and on a spring high tide generated high seas that breached St Lucia estuary mouth (see figure 6 & 7).

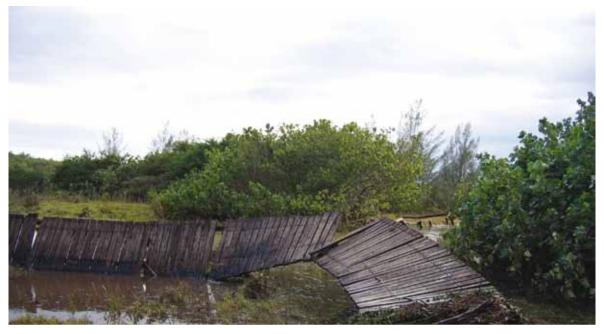
Fig 7: Cyclone Gamede's high seas damaged the board walk on the northern estuary bank— a sharp reminder of the need to keep hard infrastructure to a minimum in this dynamic environment (photograph: iSimangaliso Authority).

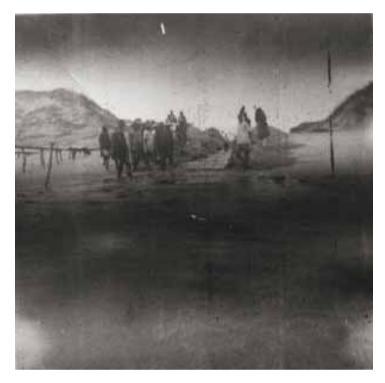
Figure 9: In 1956 the St Lucia mouth was opened with spades by the farmers (photograph: N Brits)

From 1956 a separate mouth was opened for St Lucia (see figure 9), and since then the separation of the Mfolozi and St Lucia estuary mouths has been actively maintained. This separation was considered necessary to prevent the threat of sediment accumulation in the lake.

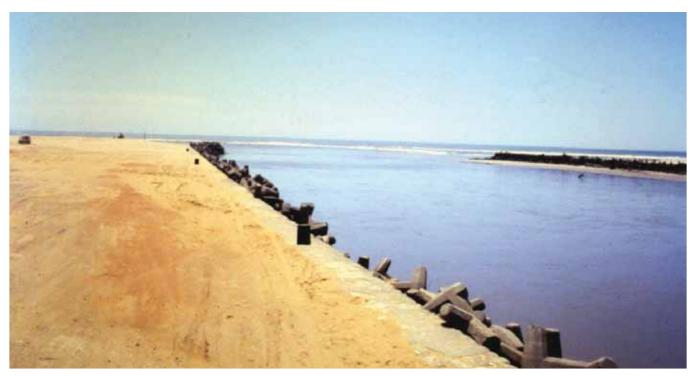
Figure 12: Lake St Lucia estuary mouth in 1983 showing the retaining walls and dolosse keeping the mouth open. (photograph: A.T. Forbes)

At that time, it was assumed that the estuarine function was 'improved' by keeping the mouth open permanently, and this was actively done by means of dredging, concrete retaining walls and dolosse such as those used in the Durban and Richards Bay harbours (see figure 10, 11 & 12).

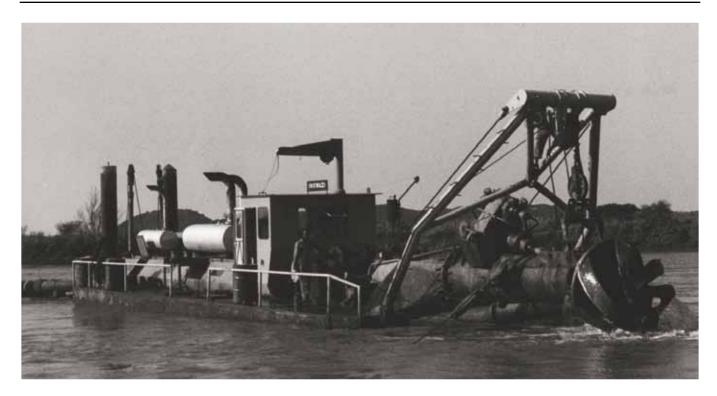
Figure 14: Dredger Inkwazi operating in the Narrows in 1976 (photograph: N Brits)

Extensive dredging in the Narrows took place in an attempt to increase exchange with the Lake and keep the mouth open (see figures 13, 14 & 15). The dredging operations and the maintenance of an open mouth were conducted by the Reclamation Unit, which was established by the Umfolozi Co-operative Sugar Planters (UCOSP) in 1952. The Government, through the Department of Water Affairs, took over the management of the Reclamation Unit in the early 1960s (see the map below which outlined the Department of Water Affairs and Forestry plan for dredging the mouth and the estuary). Thereafter the unit was housed in the Department of Public Works from 1976, the Roads Department under the Natal Provincial Administration in 1977 and then the Natal Parks Board in 1988. Ezemvelo KZN Wildlife, the Natal Parks Board's successor, took over the management of the Reclamation Unit in the late 1990s.

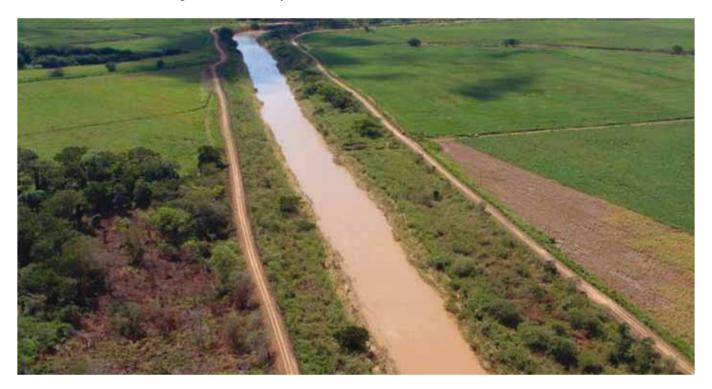
Figure 18: The canalisation of the Mfolozi river has led to an increase in the speed of the water flow. (photograph: Ezemvelo KZN Wildlife)

Agricultural development in the Mfolozi floodplain involved canalisation of the river and the removal of the wetland vegetation that slowed flood waters and filtered out sediment. Canalisation delays the overflow onto the floodplain from the main river channel, which means that more sediments are delivered to the mouth without the trapping effects of the floodplain (figure 18). The separation of the Mfolozi from St Lucia was previously considered important in preventing sediments accumulating in the estuary.

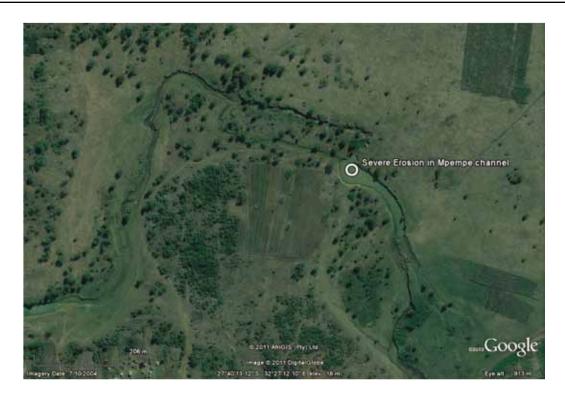
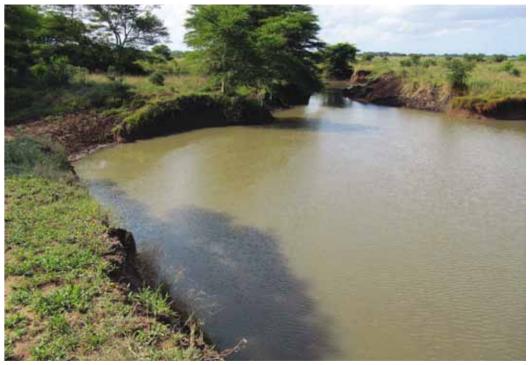
Figure 19 and 20: Erosion of the Mpempe channel caused by increased water flow as a result of the straightening of the channel to bypass the pan and bring water from the Mkhuze catchment into the lake (image and photograph courtesy of P Grundling).

After the 1967-1972 drought several interventions aimed at bringing sediment free freshwater into Lake St Lucia to prevent hyper-saline conditions were implemented. These included the digging of a channel through part of the Mkhuze swamp to short-circuit one of the pans and bring freshwater directly into the Lake. The Mkhuze intervention failed and has resulted in serious environmental consequences, which persist today (see figure 19 and 20).

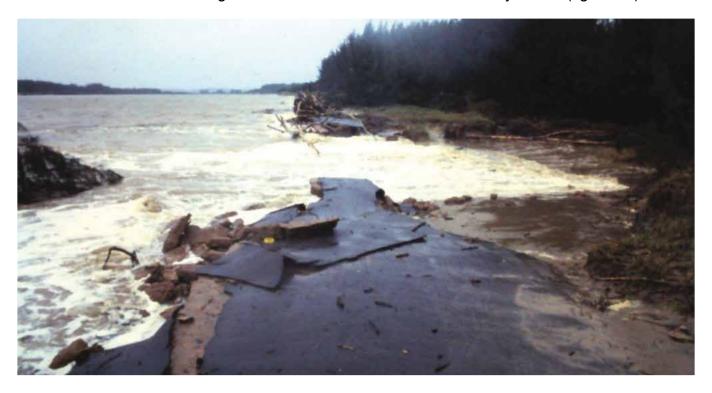
Figure 21: The cyclone Domoina floods and the associated high seas removed the concrete retaining wall, dolosse and road on the north bank at the mouth. (photograph: A.T. Forbes)

Another failed intervention was the construction of the Link Canal with the Intake Works on the Mfolozi to manage the amount of freshwater and sediment load flowing from the Mfolozi into the Narrows. When Cyclone Domoina struck on 31 January 1984 it showed that the St Lucia system cannot be managed through hard engineering solutions. The flood washed away the dredger and most of the concrete retaining wall and dolosse at the St Lucia estuary mouth (figure 21).

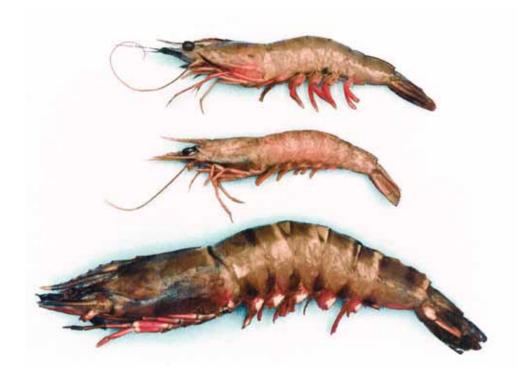
Figure 22: Commercial penaeid prawn species that use St Lucia estuary as a nursery (photograph: N Forbes)

The prolonged closures of the St Lucia estuary mouth have had a negative impact on the estuarine functioning of the estuary system. There has been a noticeable reduction in marine migrant fish species, such as the Natal stumpnose *Rhabdosargus sarba*, and the shallow water prawn fishery on the Thukela Banks has collapsed as St Lucia has ceased to function as a nursery for the shallow water prawn and other species (figure 22). It is anticipated that these shallow water prawn fisheries will recover once the estuarine functioning of the Lake St Lucia system is restored.

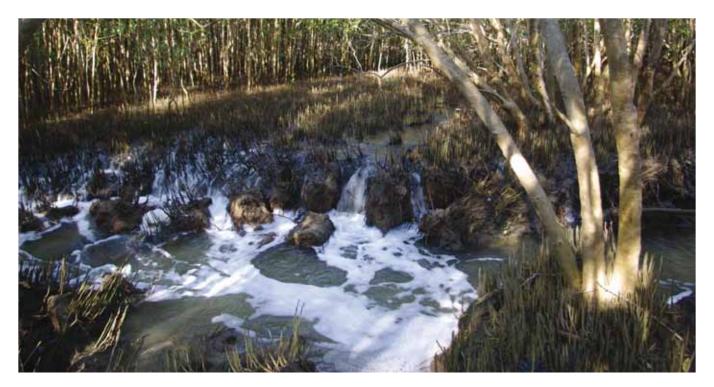
Figure 23: The Back channel diverts fresh water into the Narrows of Lake St Lucia when the Mfolozi mouth is closed (photograph: iSimangaliso Authority).

1) Diversion of water via the Back Channel when the Mfolozi mouth is closed (figure 23). This allows silt-free fresh water to enter Lake St Lucia. Ways to enhance these flows via the Back Channel are also being investigated. Back flooding of low lying sugarcane fields is a consequence of not artificially breaching the mouth. The sugar cane farms affected by back flooding are actually situated in the estuarine functional area<sup>7</sup>, and when the mouth is open the farms lie within the tidal reaches of the Msunduze River, which increases the risk of farming activity in these areas.
